MR43, MR50, MR58, MR63, MR58RL

Components and Maintenance, Continued

MR43 & Above Maintenance-Drum Shaft Maintenance/Sleeve Repair Continued

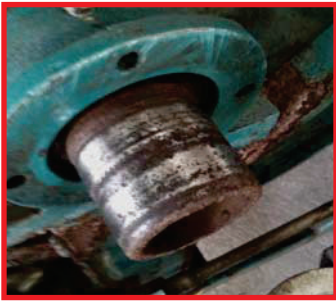
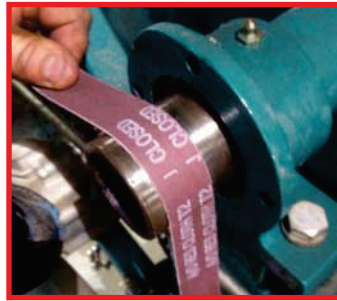
- 5) With drum shaft now exposed, inspect closely for pitting or grooves caused by neglect from not applying grease. Clean the end of the shaft with solvent to remove all old grease. If drum shaft is pitted, use emery cloth, (right image), and remove rust until drum shaft is smooth.

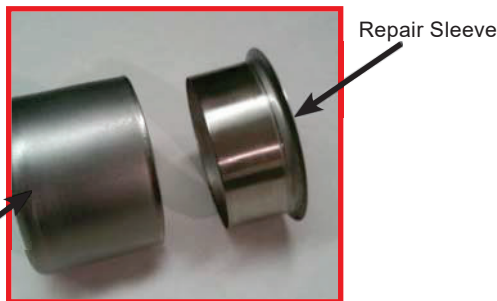
- 6) Repair sleeve components are shown at *left*.

****It is recommended to install two repair sleeves. Since there are two inlet seals that seal the shaft, one sleeve should be installed at each point that the seals contact the shaft.**

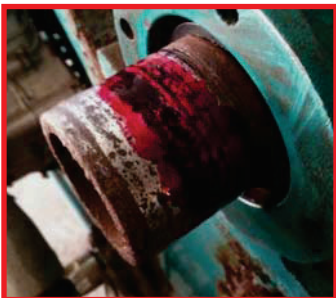
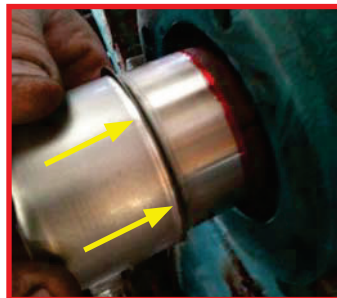
- 7) Apply some industrial retaining compound to the shaft in order for first sleeve is to be installed, (right image).
Note: If shaft is severely pitted, use a heavier compound such as JB weld instead of standard retaining compound to help fill voids left by pitting and also lock sleeve into place. Use the sleeve driver included to start the sleeve onto the shaft. The sleeve driver is closed on one end so it may be tapped gently into place with a small hammer. Continue until sleeve is located as shown on the inlet shaft.

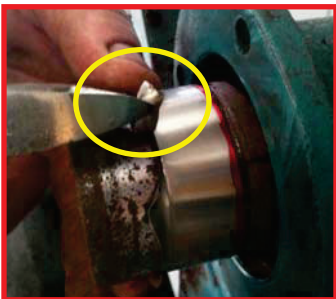
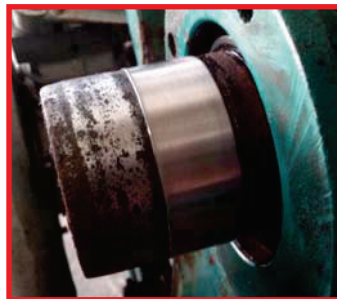
- 8) The drive ring attached to the sleeve is perforated and must be peeled away once the sleeve is in place.

Wipe away the excess retaining compound and let the sleeve sit for approximately 1 hour. The compound will lock the sleeve in place, (right image).

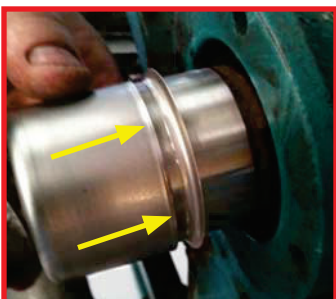
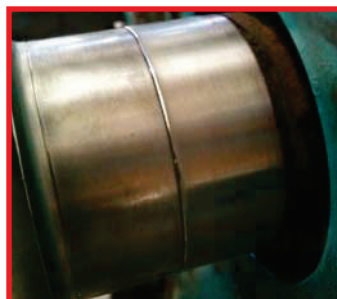
- 9) Repeat the process of applying a retaining compound to the shaft area for the second and outer repair sleeve. Again, use the sleeve driver to gently tap the second sleeve into place, (right image). Detach and peel away the drive ring from the sleeve and wipe away excess retaining compound. Sleeves must be allowed to sit for approximately one hour so the retaining compound has time to lock the sleeves into place.
